2.67" x .75 CORRUGATED STANDARD DETAILS

OUTSIDE & INSIDE CORNER DETAILS

**W.75.11**

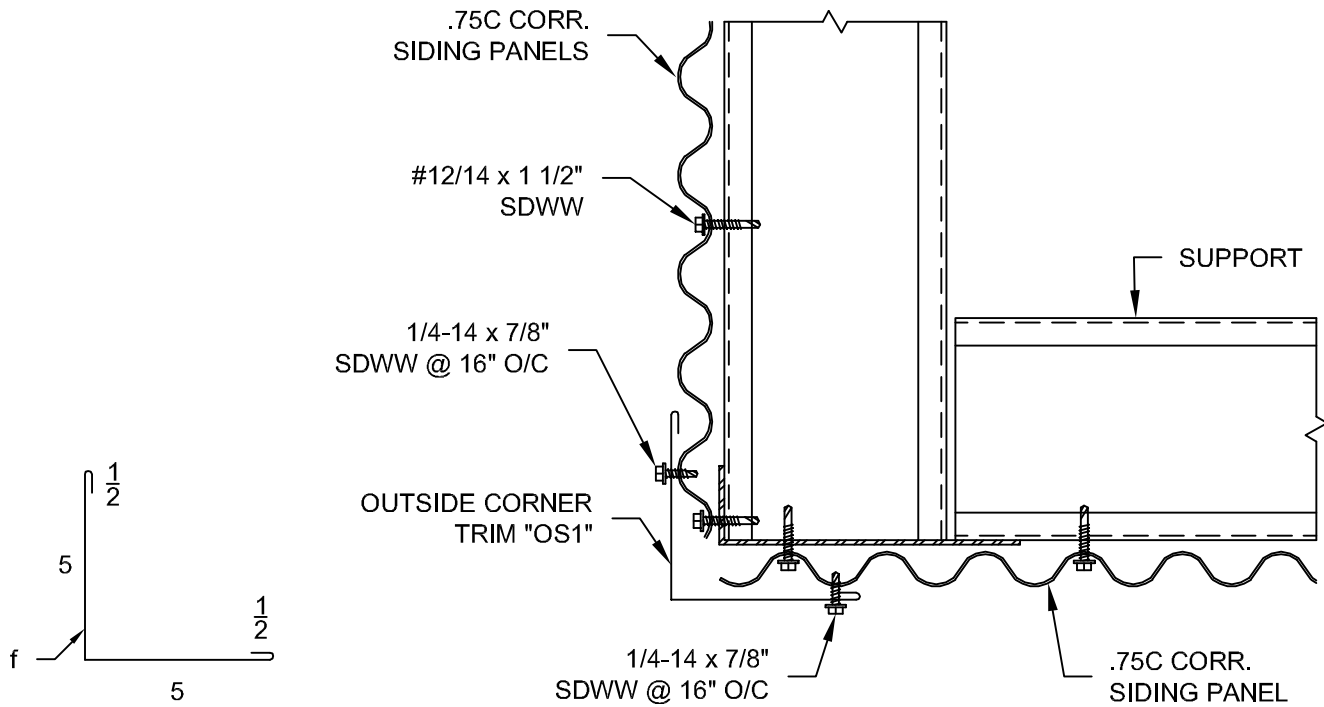
## OUTSIDE CORNER DETAIL

"OS1" OUTSIDE CORNER TRIM

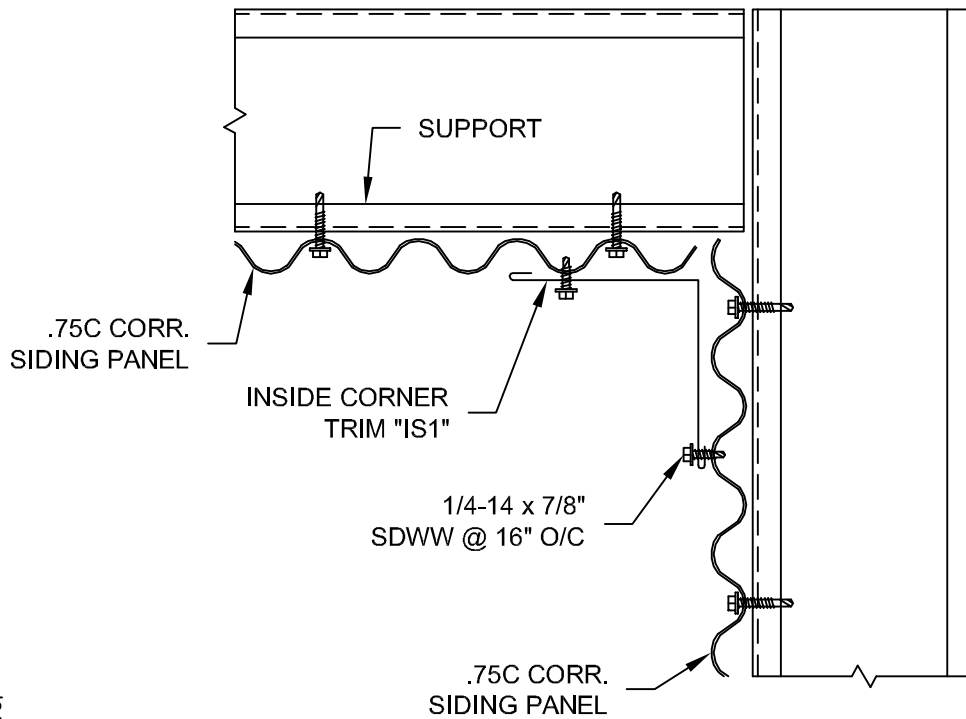
## INSIDE CORNER DETAIL

"IS1" INSIDE CORNER TRIM
