2.67" x .875 CORRUGATED STANDARD DETAILS

OUTSIDE & INSIDE CORNER DETAILS

W.875.11

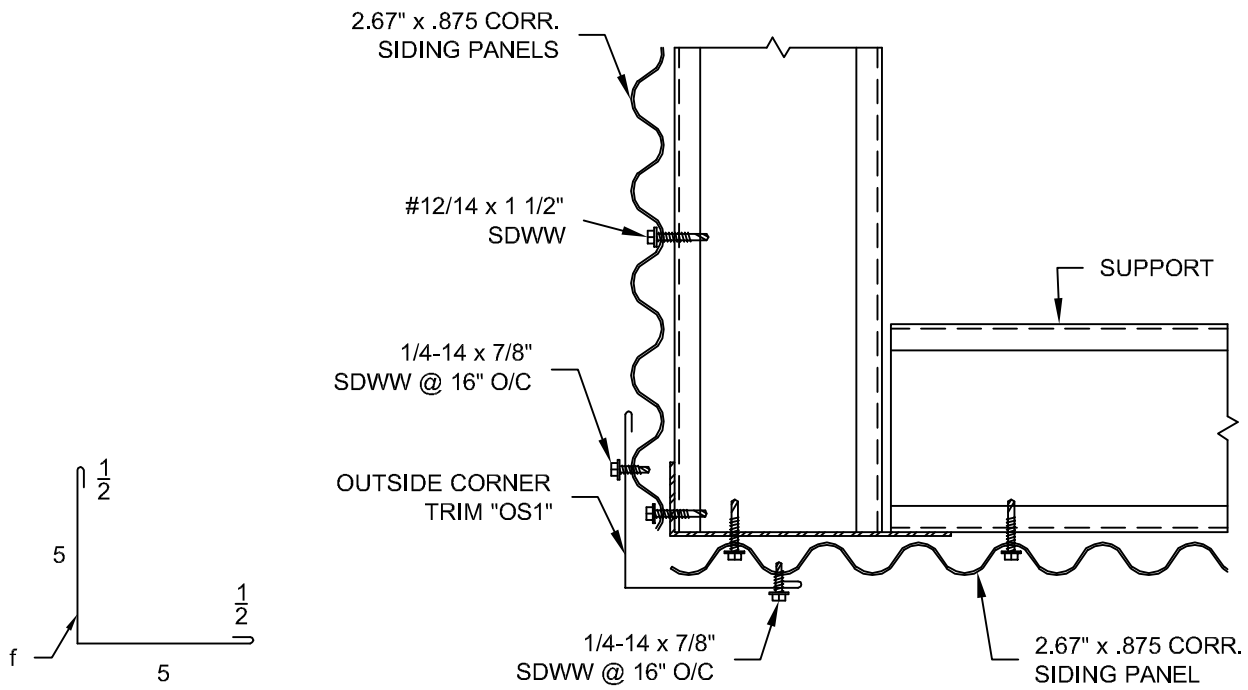
"OS1" OUTSIDE CORNER TRIM

OUTSIDE CORNER DETAIL

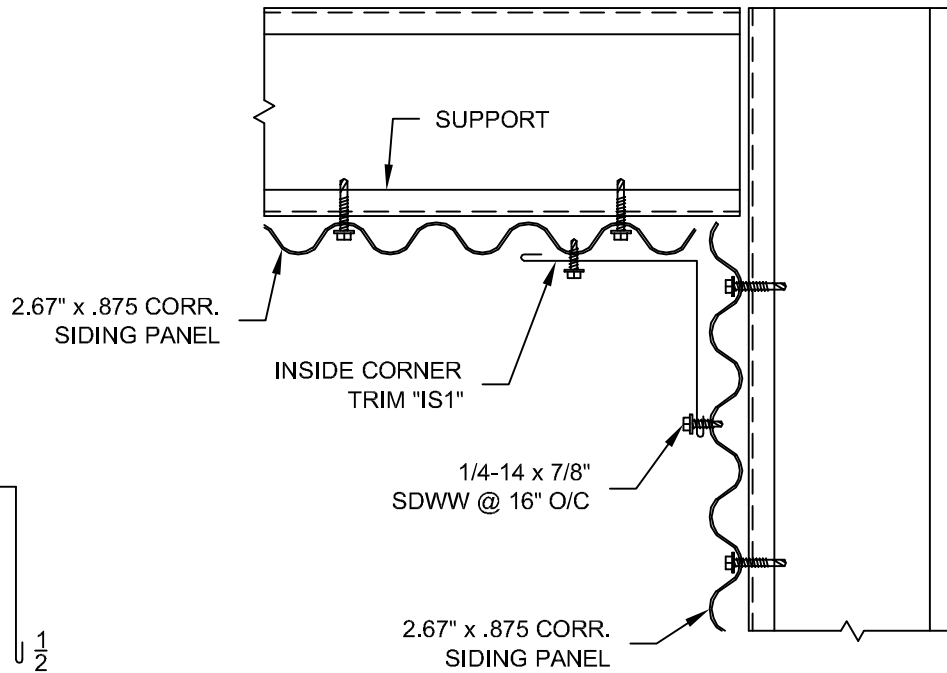
"IS1" INSIDE CORNER TRIM

INSIDE CORNER DETAIL
