UNIRIB C36 STANDARD DETAILS

OUTSIDE & INSIDE CORNER DETAILS

W.C36.11

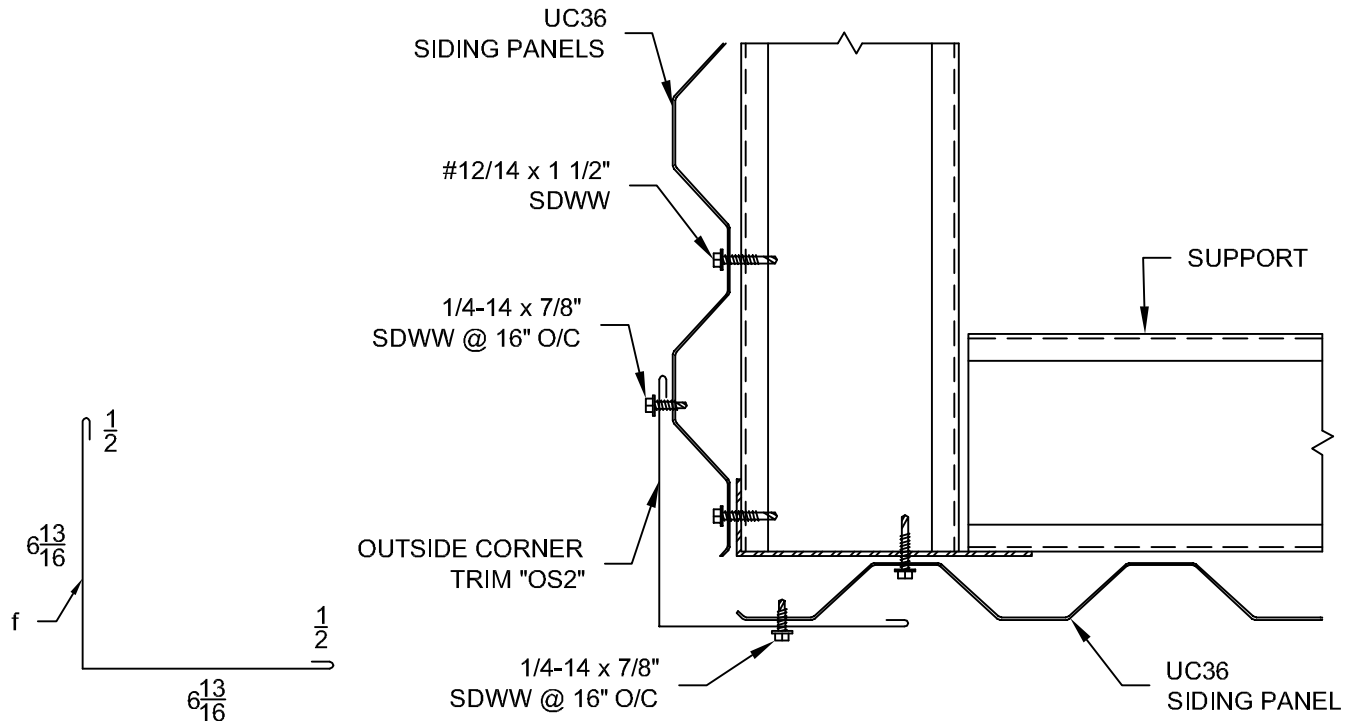
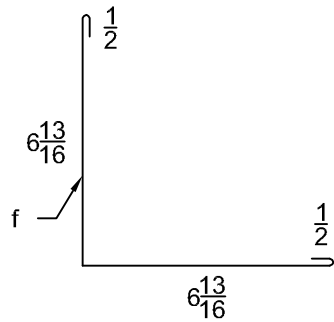
OUTSIDE CORNER DETAIL

"OS2" OUTSIDE CORNER TRIM

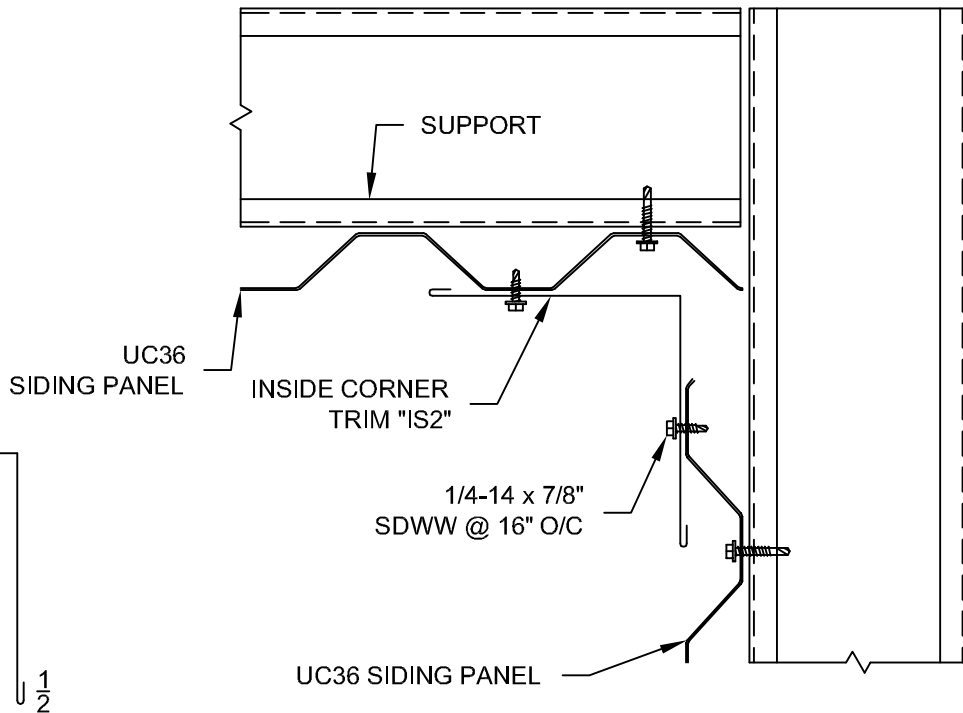
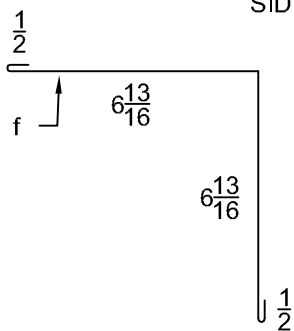
INSIDE CORNER DETAIL

"IS2" INSIDE CORNER TRIM
