## This Old House: Standing-seam roof covers historic home

A historic home located in **Knoxville, Tenn.**, the **Robert Daniel House** was designed in 1948- 1949 by James W. Fitzgibbon and constructed by George W. Qualls. The Daniels sold the house in 1961, however after the second owner died in 1970, his family let the site deteriorate. In 1982, architect Peter Calandruccio bought the home and began renovations. In July 2008, current owners Justin and Alexis Whitaker purchased the home.

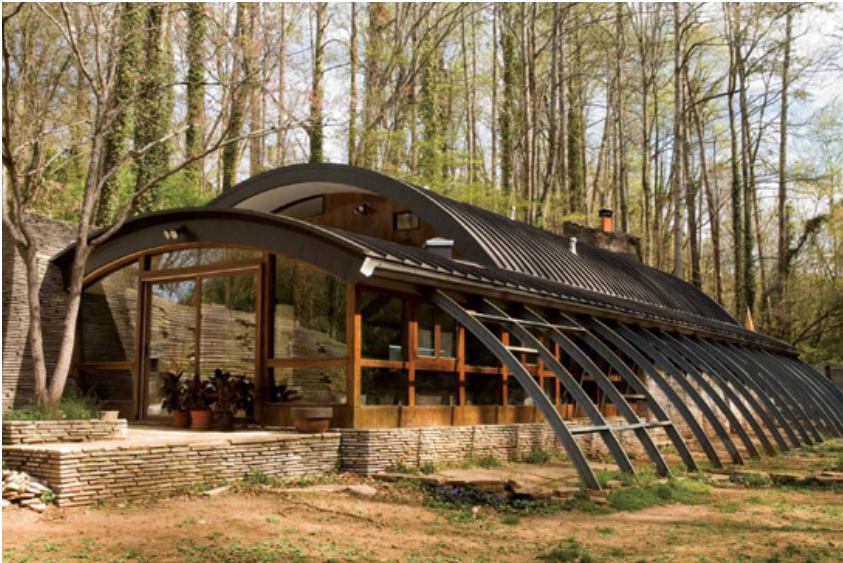
A third corrugated metal roof was installed over the second years later during building renovations. Other roofing materials were considered as replacements, but later discarded since the original roof was welded to the Quonset hut beams.

Ultimately the Whitakers found Goddard & Carter Fabrication, Louisville, Ky., to install 6,000 square feet (557 m<sup>2</sup>) of Perth Amboy, N.J.-based Englert Inc.'s Series 2500 standing-seam metal roof in Dark Bronze to cover the old corrugated material. "It took us a while to find [Goddard & Carter Fabrication], but once we did, they understood and appreciated exactly what had to be done on this historic house," Alexis said. "Even when they realized that the installation would take three weeks instead of several days, they took their time and did a wonderful job."

The house was originally designed with a corrugated metal roof that was welded to the Quonset hut beams, but ran lengthwise, creating water problems. Within months, a second corrugated metal roof was installed over the first, so water would shed to the sides of the roof.

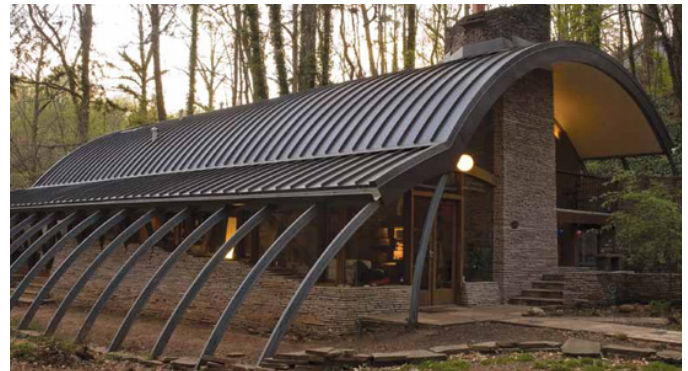
While the houses, the Daniel house has a curved metal roof that accommodates a second story loft, stone patio at one end and a balcony at the other. The arched, outrigger steel supports were salvaged from Quonset huts in the post-WWII era when the house was built. Most of the interior and exterior trim had been done in the now-extinct Wormy Chestnut. "We considered replacing it but decided to strip it and re-stain it in ebony to relieve some of the busyness of the interior caused by the interior stacked marble walls and marble flooring," Alexis noted.

The house also incorporates several hundred tons of local Tennessee pink, black and white marble in its floors, walls, a massive 12- by 25-foot (4- by 8-m) fireplace and exterior landscaping. Additionally, the septic tank is lined with local marble. The building features a double-barreled arch that embraces the entire structure including the first and second floors built into the hillside.
